Manhole Inspection Summary

Manhole # S59W__004MH

Insp Date: **11/25/08 11:20 AM**

Location Address: **7058 South Newkirk St.(Light Pole)**

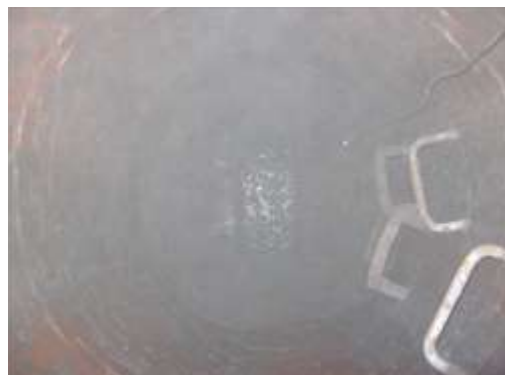
Top View

Picture is hazy due to sewer gas and steam rising out of pipe.

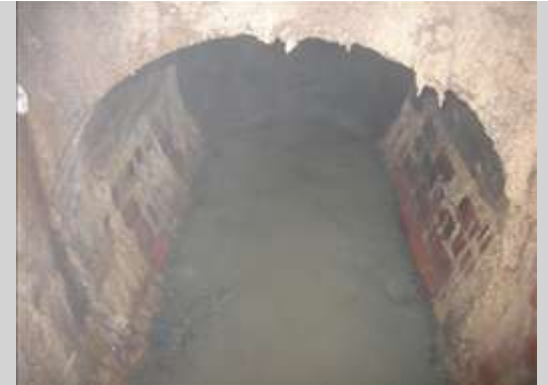
12 O'Clock Outflow

36 in. Circular Gravity Sewer
Pipe Out @ 12 O'Clock

Pipe Height: **32.4** (in.) Direct

Pipe Material: **Concrete** ☐ Pipe Lined

Invert Depth: **27.17** (ft.) Flow Characteristics: **Slow**

Infiltration: **None** Pipe Seal Cond: **Sound**

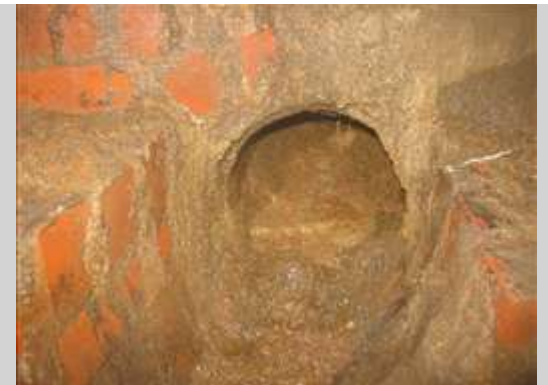
3 O'Clock Inflow

12 in. Circular Gravity Sewer
Pipe In @ 3 O'Clock

Pipe Height: **8.4** (in.) Direct

Pipe Material: **Clay** ☐ Pipe Lined

Invert Depth: **25.25** (ft.) Flow Characteristics: **None**

Connects To: **Stub connection / abandoned**

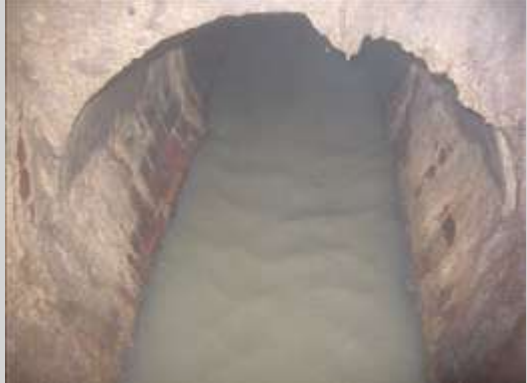
6 O'Clock Inflow

33 in. Circular Gravity Sewer

Pipe In @ 6 O'Clock

Pipe Height: **31.2** (in.) Direct

Pipe Material: **Concrete** ☐ Pipe Lined

Invert Depth: **27.08** (ft.) Flow Characteristics: **Slow**

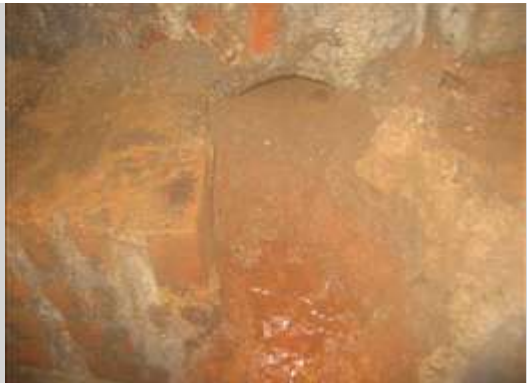
9 O'Clock Inflow

12 in. Circular Gravity Sewer

Pipe In @ 9 O'Clock

Pipe Material: **Clay** ☐ Pipe Lined

Invert Depth: **26.21** (ft.) Flow Characteristics: **None**

Connects To: **Stub connection / abandoned**
